BULLETIN NO: 278

SUBJECT: Addition of transmit interlock capability to the VC 401B Series III Communications Transceiver.

Date: October 16, 1987
 600-09278-0000

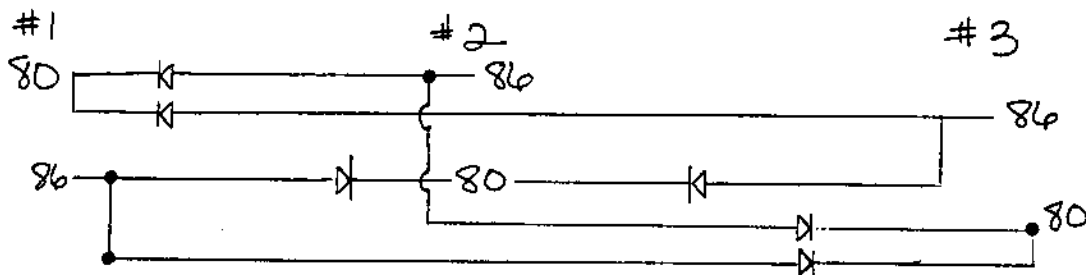
For three (3) VC 401B's installation:

It has come to the attention of BENDIX/KING that some operators of Series III VC 401B Communications Transceivers have experienced crosstalk problems. It usually occurs when there is insufficient antenna isolation to prevent the 20 watt transmitter of one VC 401B from overwhelming the receiver of the second VC 401B.

To correct this problem, unit Mod 5 to the VC 401B has been created. This modification adds a transmit interlock function that reduces the gain of the affected receiver so the copilot won't hear the pilot's transmissions on a different frequency. In order for this interlock to function two (2) wires must be added to the installation between the MIC push-to-talk line (connector P1001, Pin 80) of one transceiver and the new transmit interlock function pin (P1001, Pin 86) of the other.

In order for this modification to be effective, both unit Mod 5 and this installation bulletin must be complied with.
